NASA Contractor Report 3661

Aircraft Surface Coatings Summary Report

Staff of Boeing Commercial Airplane Company

Prepared for
Langley Research Center
under Contracts NAS1-14742 and NAS1-15325

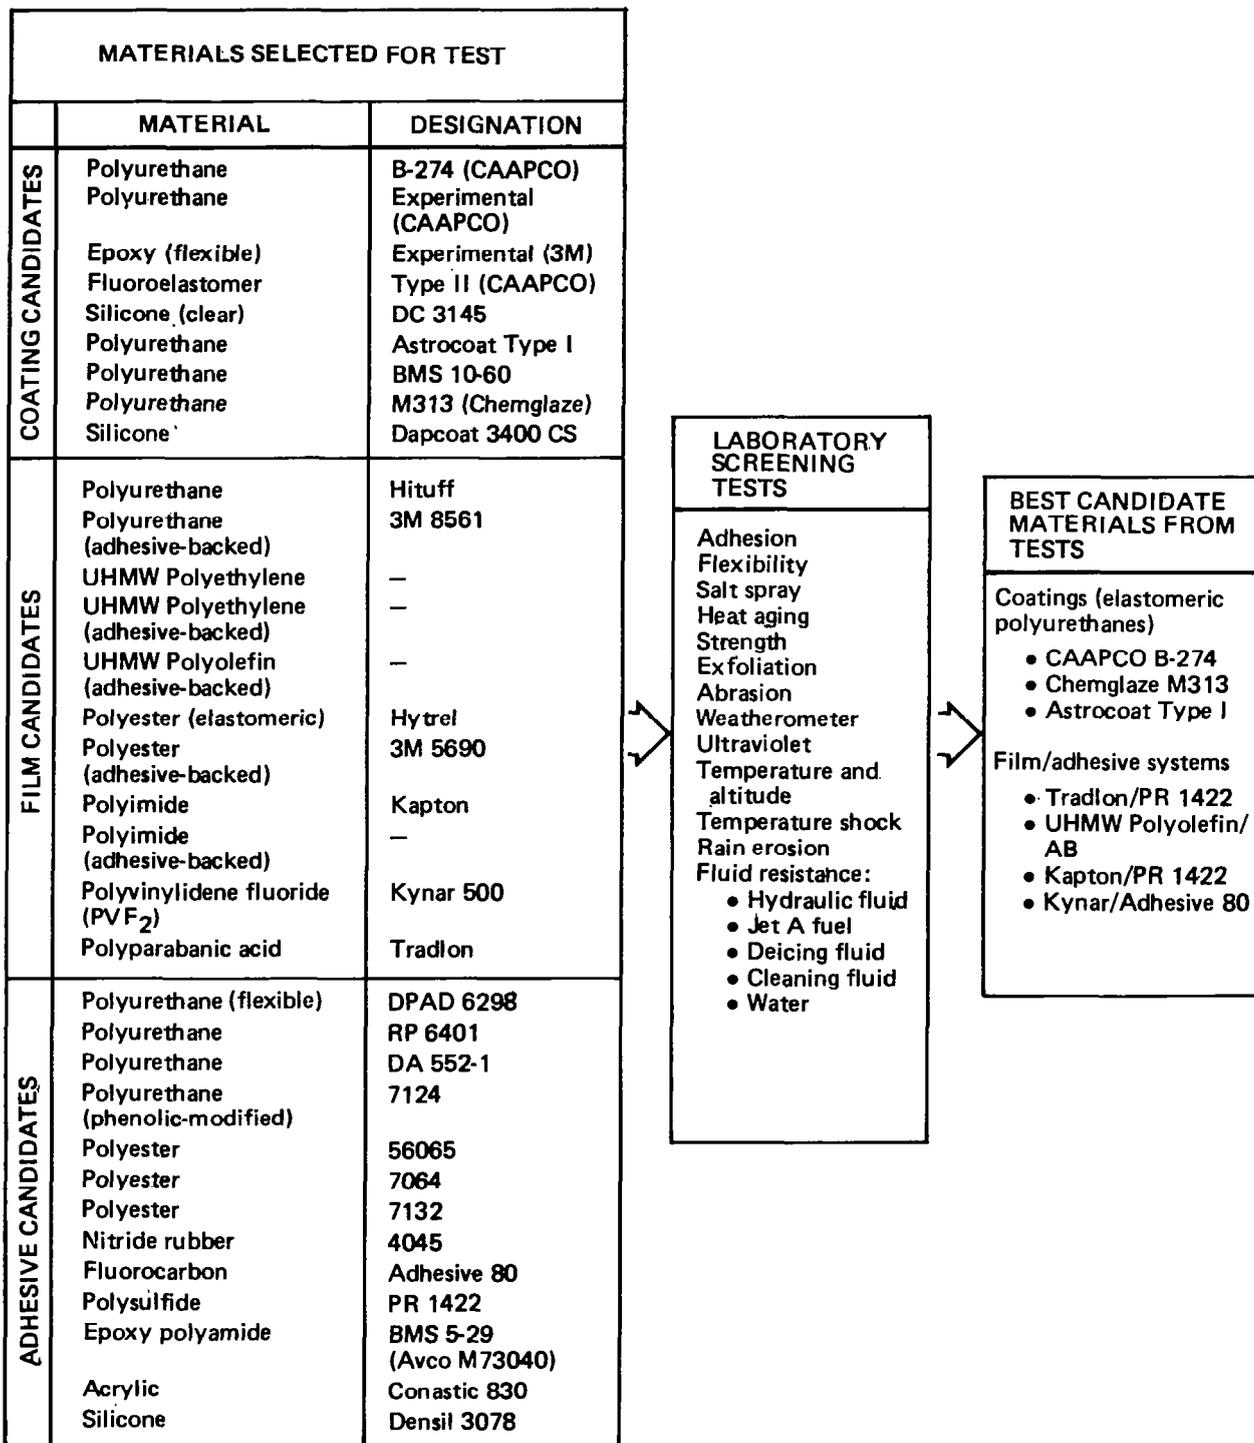
Figure 2. Laboratory Screening Process for Selection of Best Candidate Materials

Nine liquid spray-on coatings, 11 films, and 13 adhesives were selected for evaluation from the large number of available products. The liquid coatings and 60 film/adhesive combinations were then subjected to the laboratory screening tests listed in Figure 2. The liquid coatings and 16 film/adhesive systems were retested to more rigorous requirements to produce the 3 coatings and 4 film/adhesive systems of Figure 2 as the best candidate materials.

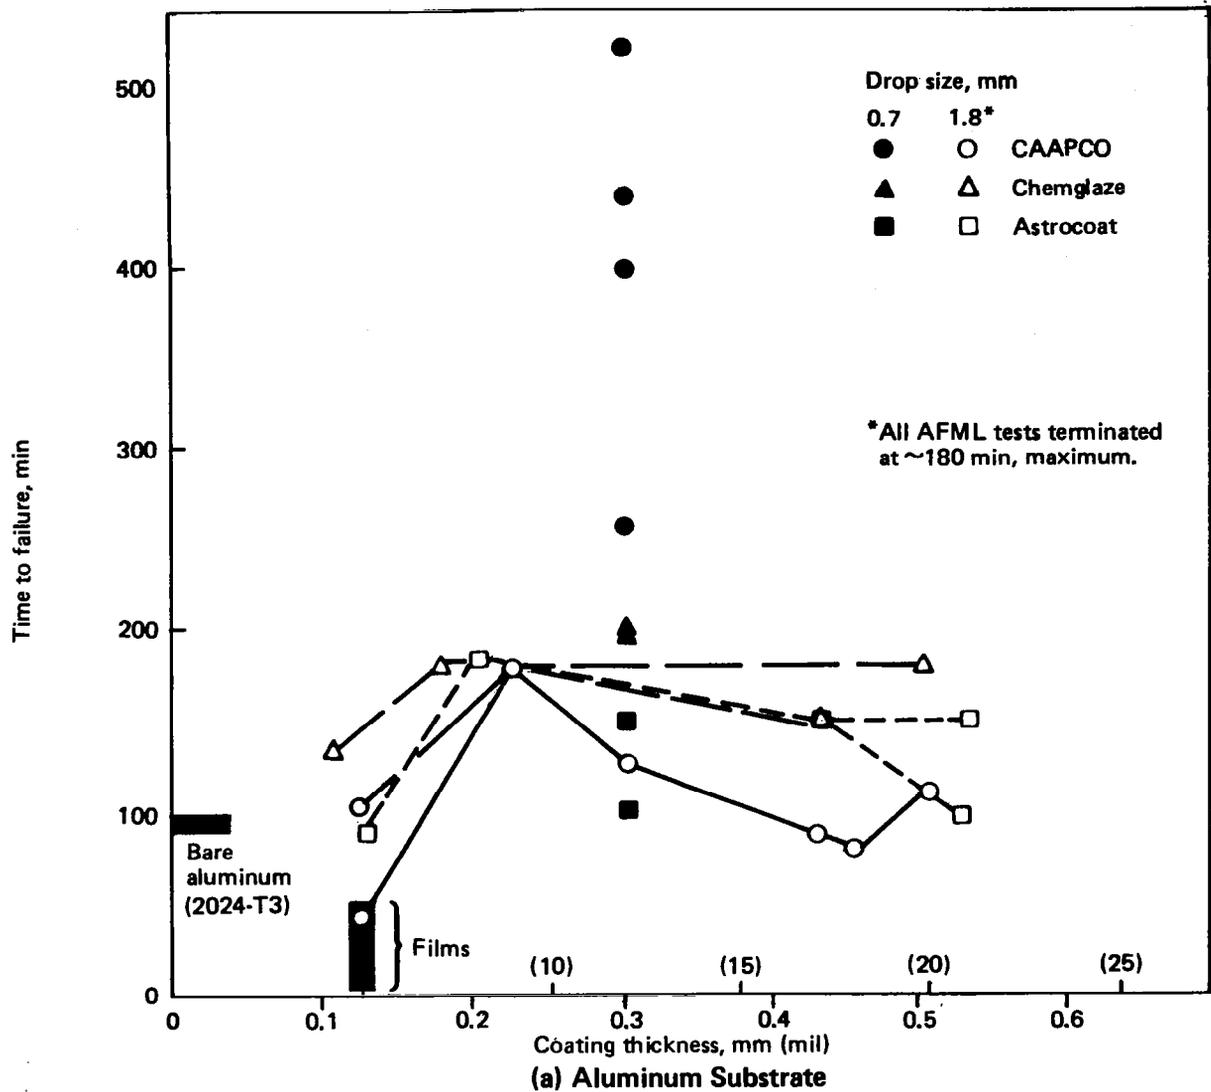
Figure 3. Summary of Rain Erosion Tests at 224 m/s (500 mi/h)—Rain Rate, 2.54 cm/h (1 in/h)

Rain Erosion. A summary of rain erosion test results is presented in Figure 3. The tests were run in the Avco Systems Division facility (solid symbols), which produced 0.7-mm (0.028-in) diameter rain drops and in the Air Force Materials Laboratory (AFML) facility (open symbols), which produced 1.8-mm (0.07-in) rain drops. All tests were at 224 m/s (500 mi/h) and with a rain rate of 2.54 cm/h (1 in/h).

The durability of 12-mil CAAPCO and Chemglaze coatings, tested in the Avco facility, was much greater than the bare aluminum substrate or any of the 5-mil films (fig. 3a). The average time to when failure of the four CAAPCO specimens started to occur was 402 minutes, which is roughly equivalent to 6000 flight-hours in airline service. The AFML tests indicated that the coating thickness could be reduced to about 9 mil without sacrificing erosion life.

Erosion tests performed on bare and coated composite substrates (fig. 3b) revealed that the bare materials had a very short erosion life. Although the coatings were beneficial, even the best combination (CAAPCO over fiberglass) would begin to fail after the equivalent of about a year of airline jet transport operation.

Coating thickness = 0.23 mm (9 mil); drop size = 1.8 mm

(b) Composite Substrates

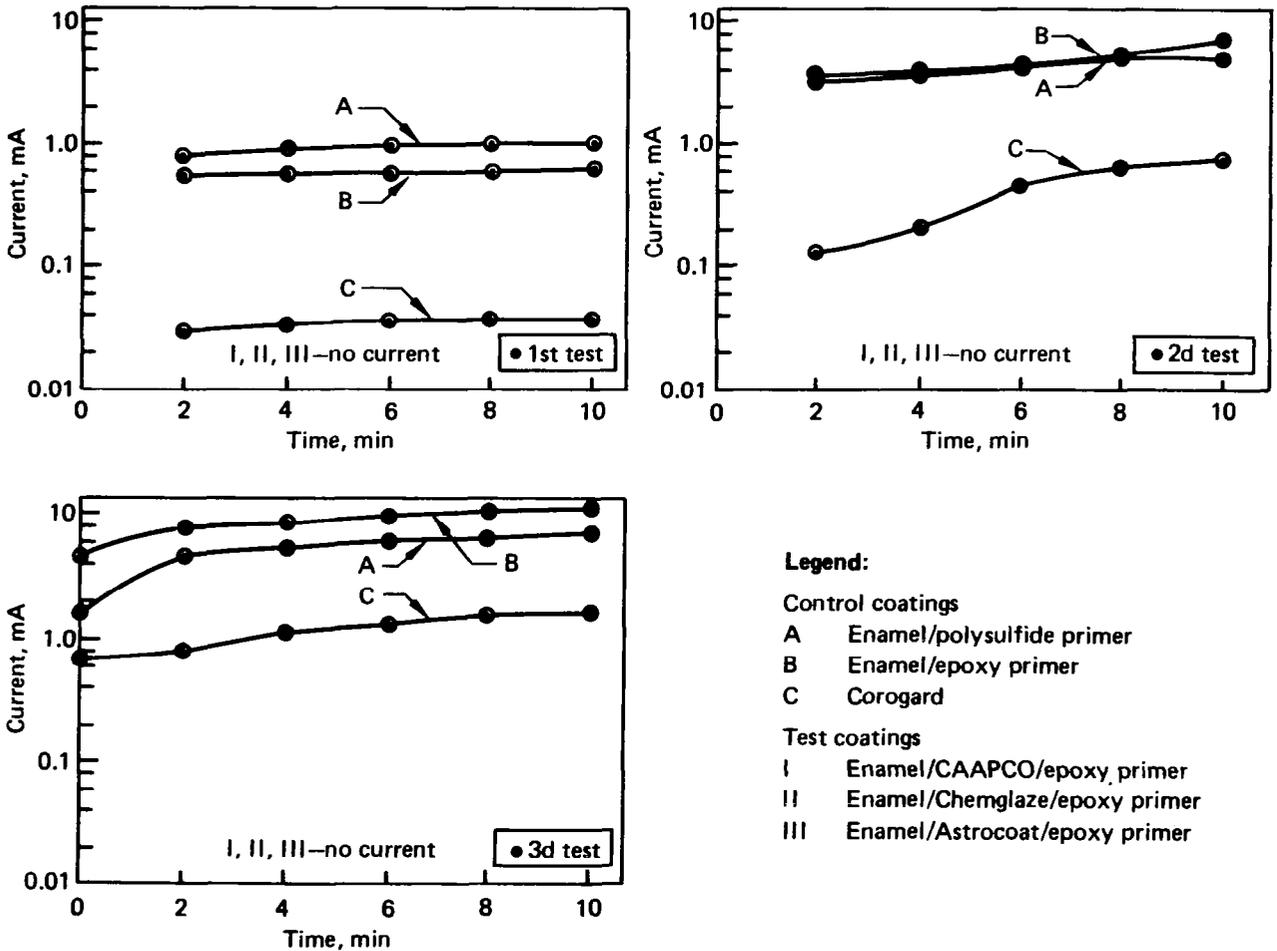
Figure 4. Dynamic Test Results—Potentiostat Current Flow Measurements

Results of the dynamic tests, shown as Potentiostat current flow, are presented in Figure 4. The three control coatings showed positive current flow during each of the Potentiostat tests, indicating a corrosion path at fastener heads where the coatings had failed. Control coating C (Corogard), which had the lowest current flow of the control coatings, contains sacrificial aluminum particles that greatly delay corrosion attack of the substrate. None of the elastomeric test coatings (coatings I, II, and III) showed any current flow, indicating that the seal over fastener heads had not fractured during the high cyclic loads imposed on the specimens.

Although the dynamic tests showed that the test coatings have superior qualities for protecting against corrosion, the long-term effects of environmental exposure must be proved satisfactory before the industry can substitute elastomeric polyurethane dual coatings for coatings currently used to protect critical aircraft structure from corrosion.

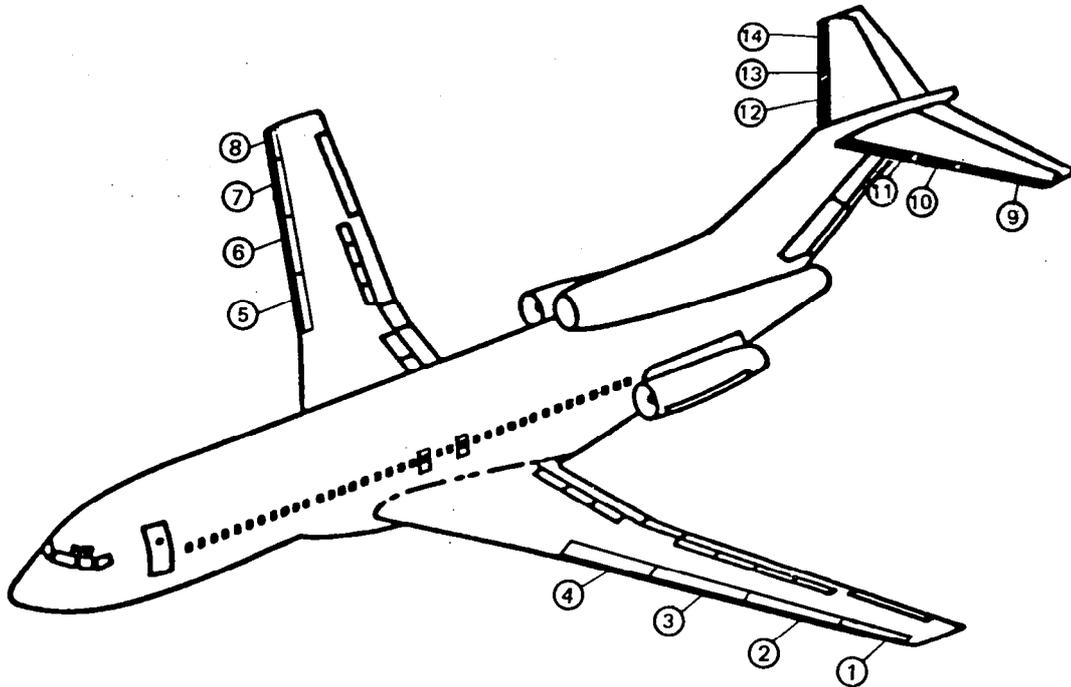
Figure 5. Coating Configurations for Airline Service Evaluations

*Configuration for first Continental evaluation.
Changes in second evaluation as noted:

- (1) Outboard half only.
- (2) Inboard half bare. Laboratory-coated control part installed on outboard half with equal panels of CAAPCO, Astrocoat, and Chemglaze.

Delta. CAAPCO and Chemglaze coatings, applied as shown in Figure 5, were evaluated over a 2-year period on a DL B727 flying U.S. domestic routes. During this period, 6435 flight-hours were accumulated. Coatings on the left side of the airplane were applied over an epoxy primer (BMS 10-79); those on the right side were applied over a wash primer (Hughson 9924).

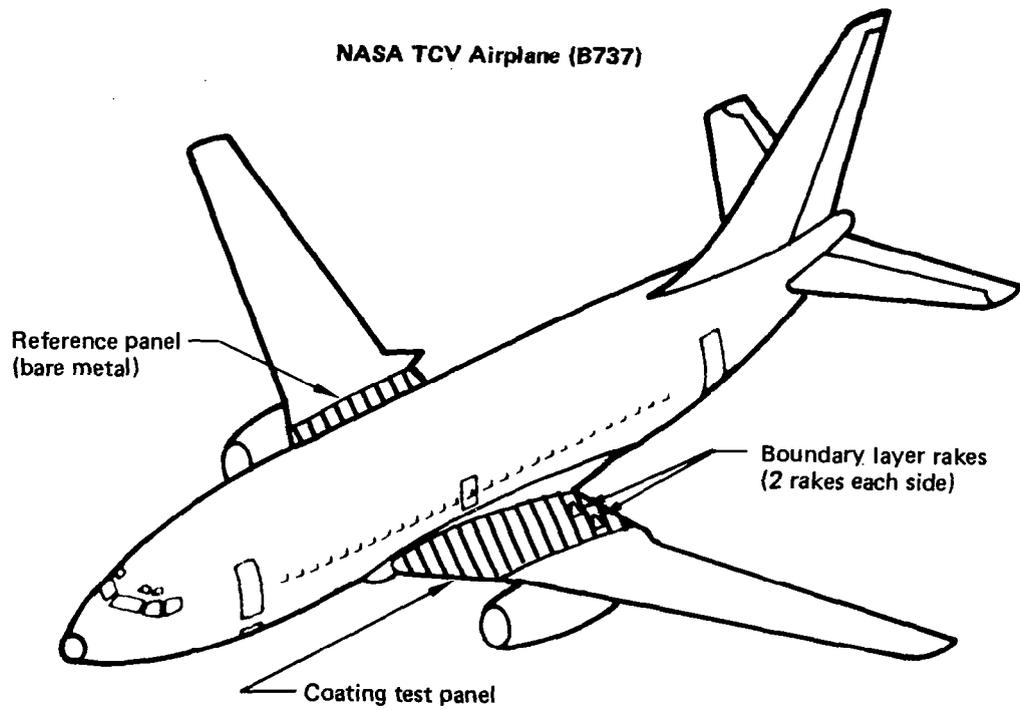
Figure 9. Drag Measurement Test Configuration

The test panels, shown in Figure 9, spanned 203 cm (80 in), beginning 66 cm (26 in) from the side of the body and extending to the proximity of the nacelles. Coatings were applied to the left wing test panel back to the 75% chord line. The right wing panel was stripped to bare metal and was used as a reference panel in all flights. This allowed a direct comparison of data taken simultaneously on test and reference panels under identical test conditions.

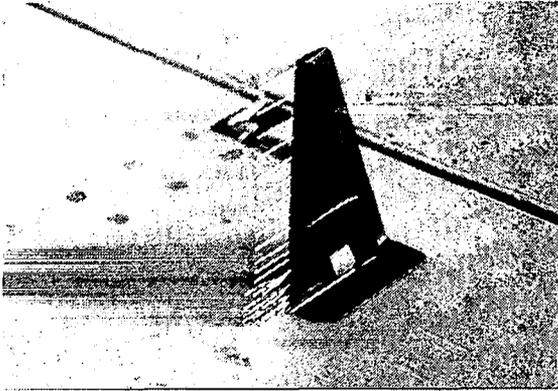
Boundary Layer Rake

Figure 10. Sensor Installations and Examples of Data Obtained

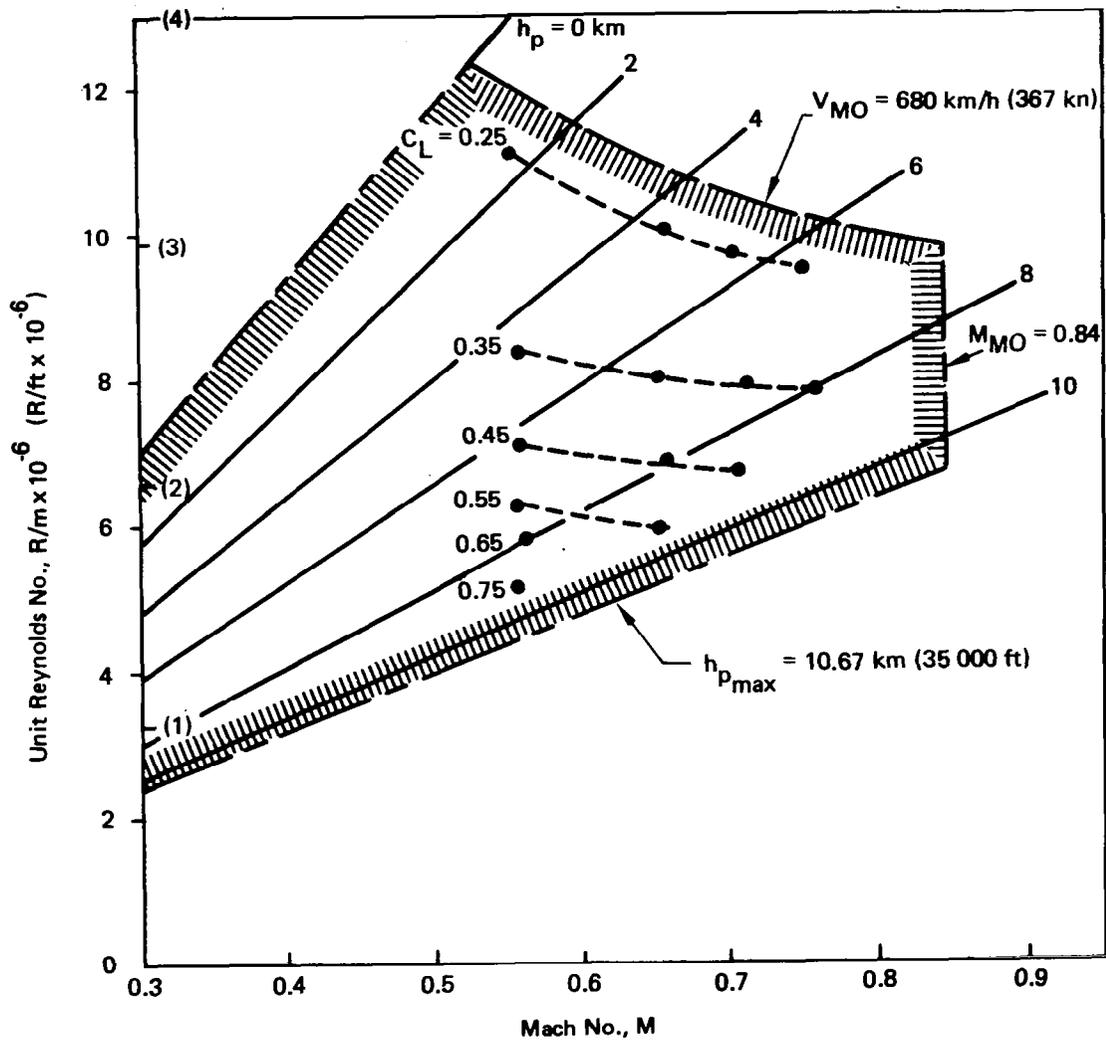
Figure 11. Range of Test Conditions

Data were taken at 15 flight conditions during all flights except flight 3a (4 conditions), covering a wide range of cruise operations within the flight envelope of the test airplane (fig. 11). The Corogard application for flight 4 was intended to match the then-reported fleet average roughness of 150 μin , however, it cured at 160 μin . More recent surveys indicate a B737 fleet average roughness of about 130 μin . Severe erosion was simulated for flight 3a by bonding No. 50 grit particles along a 7.6-cm (3-in) strip of the test leading edge. The simulated rough leading edge is compared in Figure 12 with a badly eroded leading edge of an airline transport photographed on the flight line. (The B737 is limited to leading-edge roughness of No. 240 grit equivalent to ensure adequate stall margins in low-speed flight.)

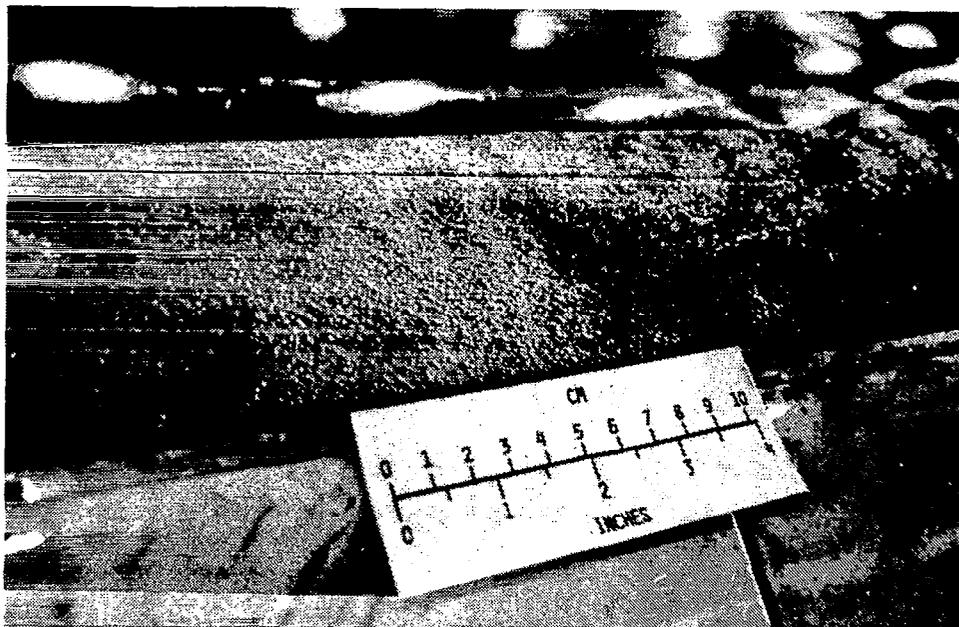
Simulated
rough leading
edge (flight 3a)

During one flight in the B737 TCV test series, a severely eroded leading edge was simulated with a 7.6-cm (3-in) strip of No. 50 metallic grit glued onto the leading edge ahead of the wing test section. This strip caused a drag increment of approximately 0.3%. Combining this with the total airplane drag of 0.55% gives the possible total drag reduction, 0.85%. A cost/benefit analysis based on the 0.85% drag reduction indicated a net benefit per airline B737 of up to \$10 000 per year with fuel costs at 26.4¢/L (\$1.00/gal).

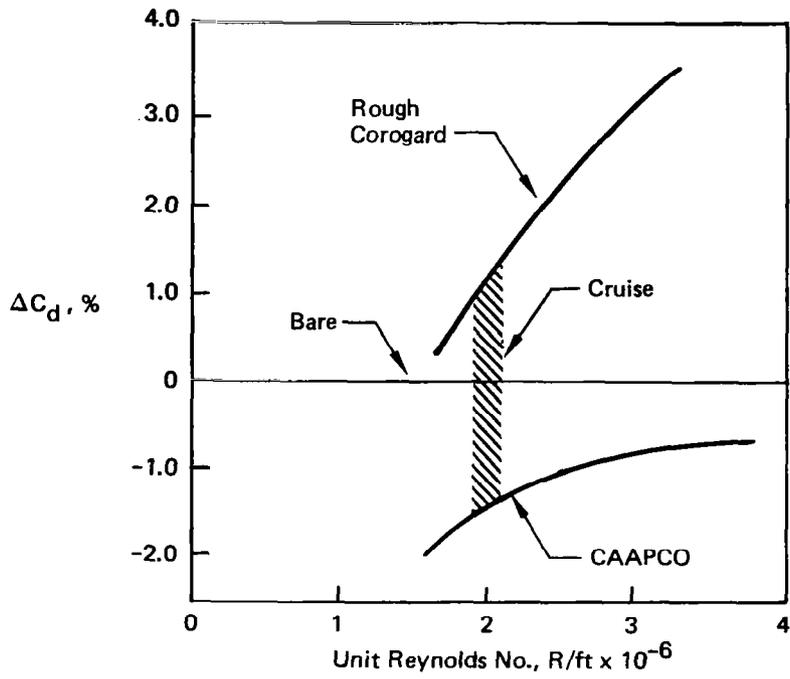
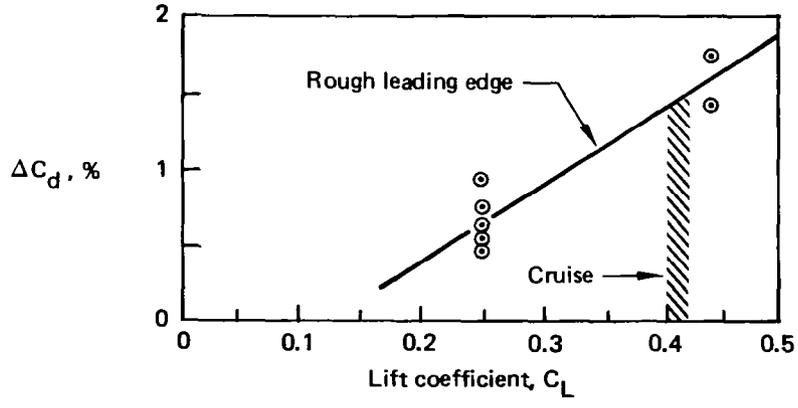
Figure 13. Effect of Coatings and Rough Leading Edge on Section Profile Drag

Test Results. Test results were analyzed to determine the effects of coatings on section profile drag at the measurement station and were extrapolated to effects on total airplane drag of the test airplane. The analysis method and extrapolation process are fully described in References 3 and 4.

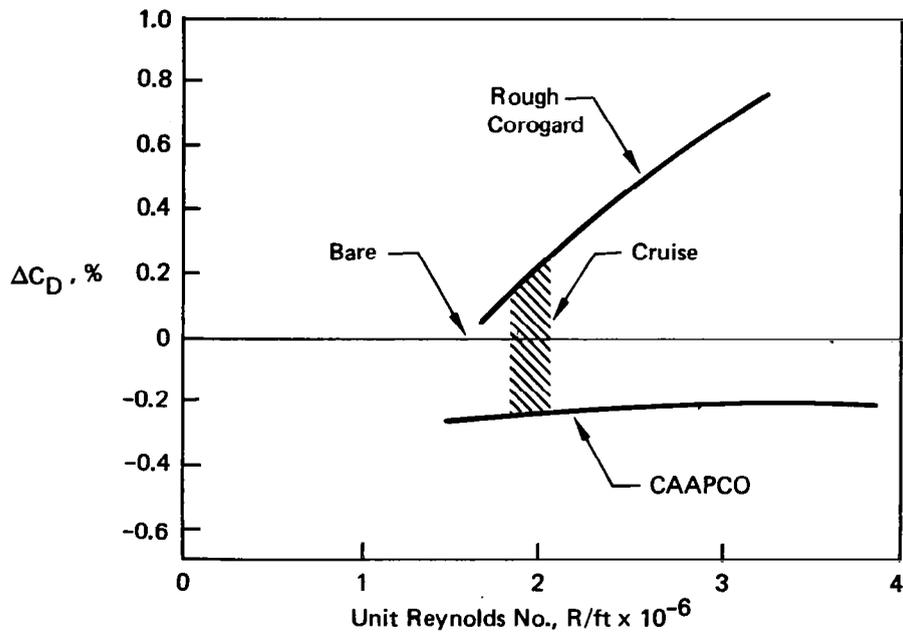
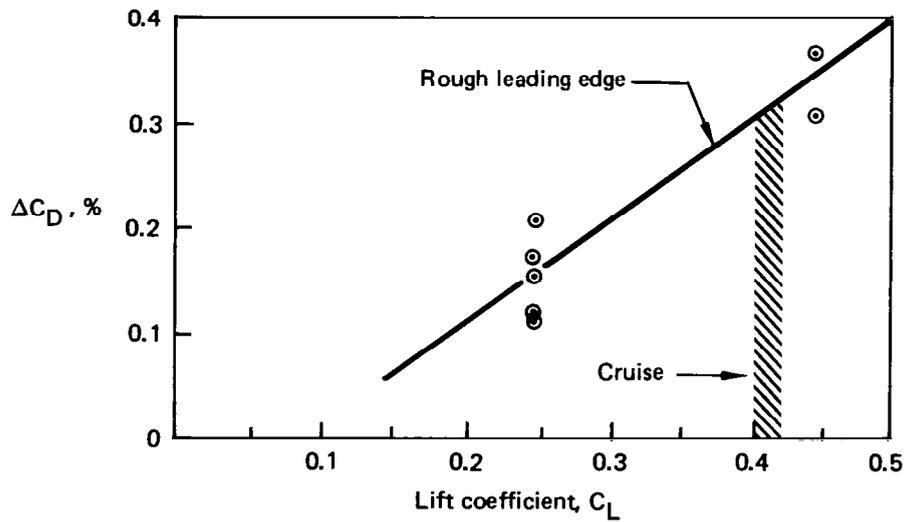
Figure 14. Effect of Coatings and Rough Leading Edge on Total Airplane Drag

- At a typical cruise condition, lift coefficient = 0.45 and Reynolds number = 6.5 million per meter (2.0 million per foot), the total airplane drag increments relative to the bare surface for the test airplane are estimated to be:

| Rough Corogard (160 μin) | 0.2% <u>increase</u> |
| Rough leading edge | 0.3% <u>increase</u> |

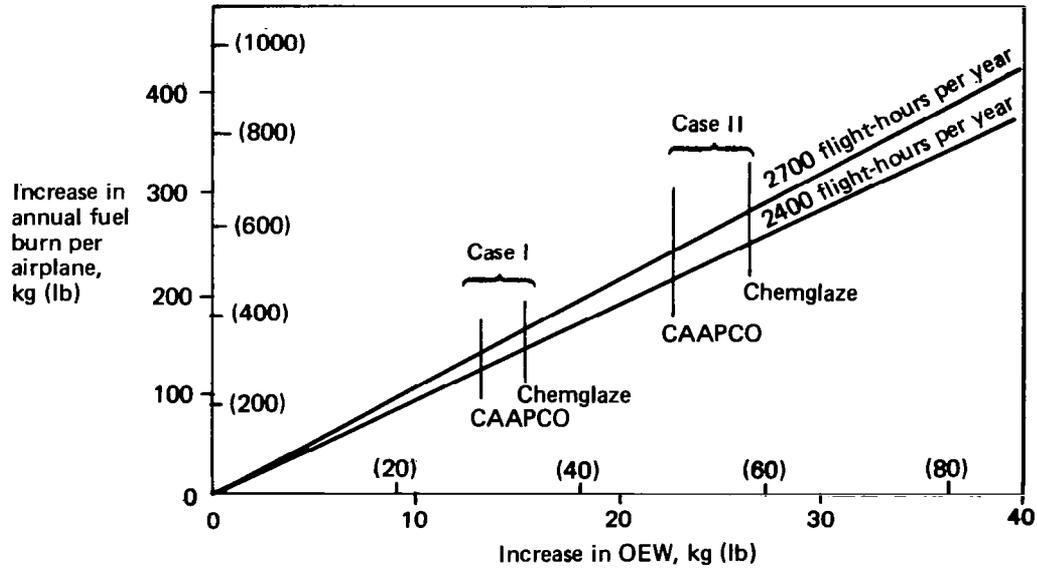
Figure 16. B737 Fuel-Burn Sensitivity to Increase in Weight

Annual utilization rates of 2400 and 2700 flight-hours were used to cover the experience of various airlines. Based on flight service evaluation results, a leading-edge life of coatings was assumed to be 6500 flight-hours for CAAPCO and 5000 flight-hours for Chemglaze. Life of inspar coatings or standard paint was assumed to be 12 000 hours, equivalent to a major scheduled maintenance interval. Costs of labor, materials, and airplane downtime for coating application were assessed in 1981 dollars. The fuel-burn penalty for added weight of coatings over the standard paint configuration, shown in Figure 16, was included in the analysis.

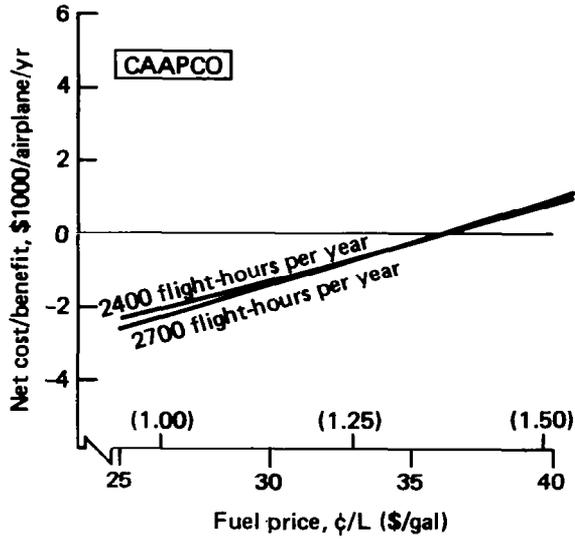
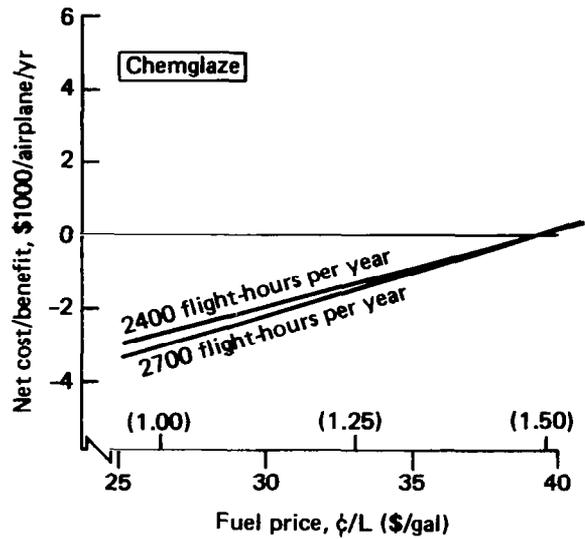
(a) Case I—Leading-Edge Coatings

Results of the cost/benefit analysis are summarized in Figure 17. Applications of coatings to the leading edge only (case I) for erosion protection do not produce a net benefit to the operator from reduced fuel burn until fuel price exceeds 36¢/L (\$1.37/gal) for CAAPCO or 40¢/L (\$1.51/gal) for Chemglaze applications. Some operators with severe erosion problems might benefit from a case I application through other considerations such as reduced costs for leading-edge maintenance and parts replacement or improved low-speed handling characteristics. Case II applications indicate a net annual benefit per airplane of \$10 000 to \$20 000, depending on fuel price and annual utilization. These benefits are based on replacing severely eroded leading edges and rough Corogard with the elastomeric coatings that mask minor substrate excrescences and present a surface smoother than the bare substrate.
